DECLARATION

Re: Application of Darrel Meyer  
Serial No.: Divisional of 09/890514  
Filed: October 12, 2001  
Titled: Weight Bearing Systems and methods Relating to Same

**RADCO TEST REPORT**  
Test Report No. RAD-1777  
Project No. C-6129

Static Load Test on Truss Assembly

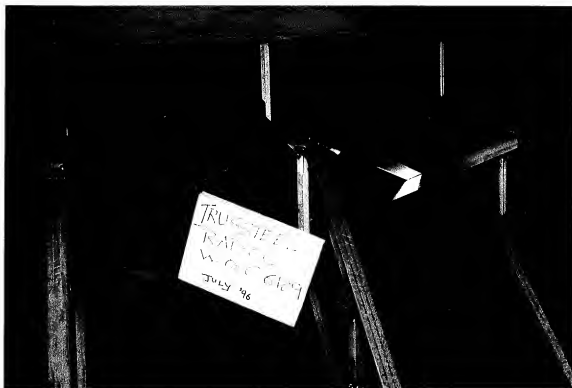
# TYPICAL CROSS BRACING OF THE THREE TRUSSES

The test specimen consisted of three (3) trusses assembled and held together using end caps and cross bracing at the quarter points. The trusses were submitted and assembled by Trussteel. A  $\frac{3}{4}$ " plywood deck was fastened to the top chord of the trusses to provide the loading platform.

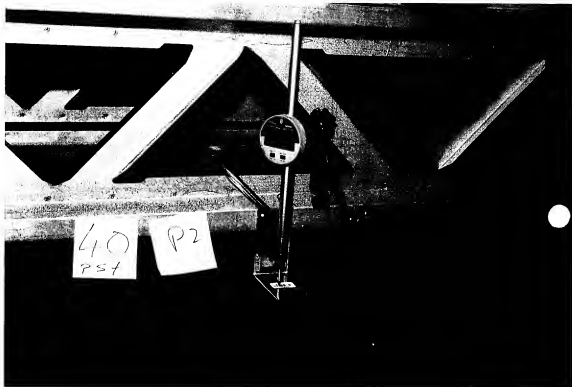
# DIGITAL DIAL INDICATOR MEASURING DEFLECTION OF BOTTOM CHORD

The load was applied using 70 lbs. lead ingots. The ingots were placed on the plywood deck at preset locations which were selected to create a uniform loading condition at every increment of load application. Deflection measurements were taken along the bottom chord at midspan and at quarter points of each truss. Deflection gauges accurate to a minimum of 0.001" were used.

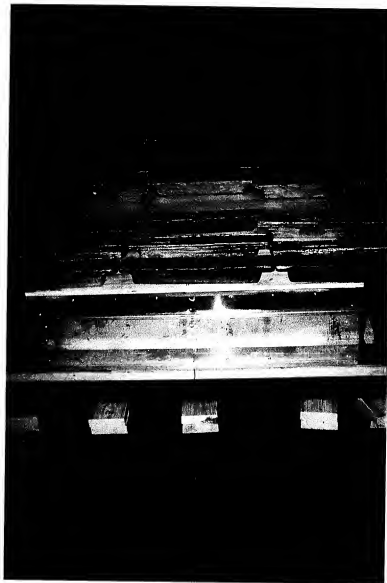
**VIEW OF LEAD INGOTS ARRANGED ON THE PLYWOOD DECK**

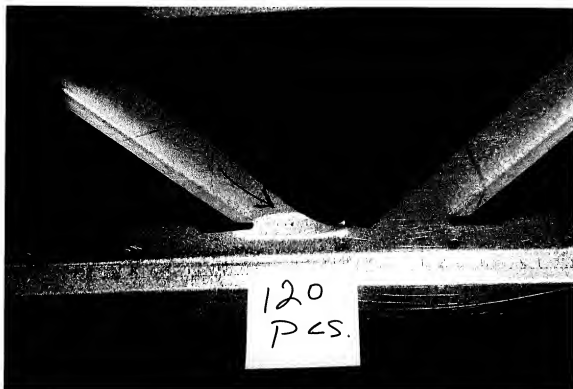
ONE WEB 20" FROM THE END ON ONE OUTER TRUSS STARTED TO BUCKLE @ 71.186 PSF

At 8,400 lbs. of dead load or 71.186 psf, one web on one outer truss 20" in from the end started to buckle and deform. At this point the loading was continued to the next increment, and at 8,820 lbs. of dead load or at 74.746 psf, a second web on the same truss and 39" from the same end started to deform and buckle. The test was concluded at this point.

One web 20" from one end (the full web end) on one outer truss started to deform and buckle when an evenly distributed load of 120 pcs. of lead ingots was applied i.e. 8,400 lbs. or 71.186 psf.  
 A second web 39" from the same end (the full web end) on the same outer truss started to deform and buckle when an evenly distributed load of 126 pcs. was applied i.e. 8,820 lbs. or 74.746 psf. The test was concluded at this point.
